Control of blue algae with ultrasound – the effects on fish

Report: VA2007_28

Hoogheemraadschap van Rijnland

October, 2007

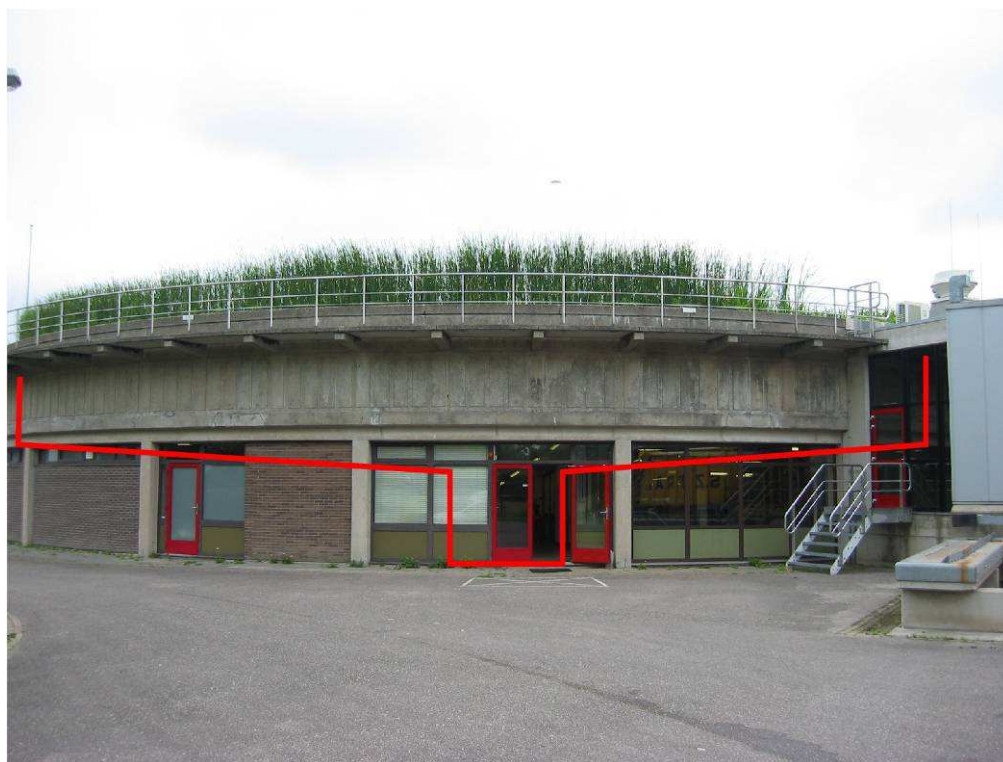
The basins at AWZI Zwaanshoek are filled with effluent water from the purification process and are continuously flowed with a small amount of this water. The basins have not been dry for a number of years, which means an ecological balance has been able to develop in the water. The basins are located on the roof of two buildings, and both buildings are connected in the middle. Image 2.1 shows the side view of one of the basins. The red line in the image indicates the dimensions of the bottom of the basin. It's clear that the bottom of the basin is funnel-shaped. The water depth in the center is about 4 to 5 meters. Both basins are similarly dimensioned.

image 2.1 Side view of one of the basins.

Due to the dimensions of the basins and the present obstacles, fishing in the basins proved to be a difficult task. The difficulty was, among other things, caused by the funnel-shaped bottom of the basin and the resulting depth in the middle (Image 2.1). The fish could flee and were almost impossible to catch in this depth. A dragnet could not be used to fish in the tip of the funnel shape. The constructions (planters) at the banks of the basins also made fishing with a dragnet impossible. As a result of the planters, a dragnet could not be closed at the bank and fish could escape by hiding under the construction.

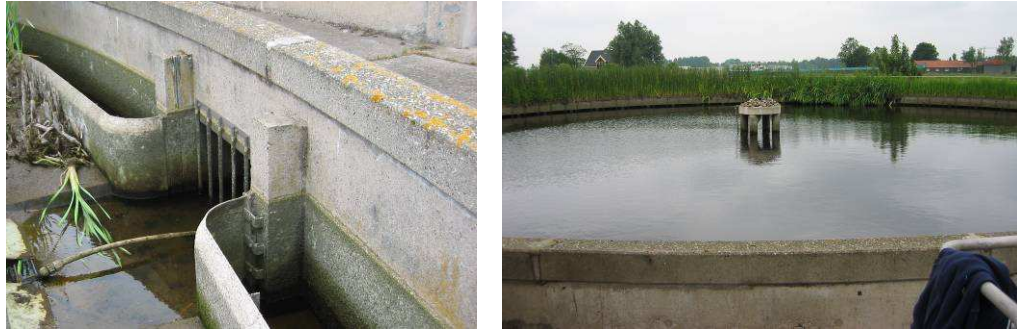
The basins are connected via a rectangular tunnel, which makes it possible for fish to migrate from one basin to the other. Image 2.2 shows this tunnel. When image 2.2 was taken, the water level was approximately 70 centimeters lower than the normal water level. Image 2.3 shows a top view of the two basins. There's a structure on posts along the inside of the basins, which contains a substrate, in which different types of waterside plants grow. Furthermore, there's a large post in the middle of the basin, which was previously attached to a rotating arm.

image 2.2 View of the tunnel and an image of one of the basins.

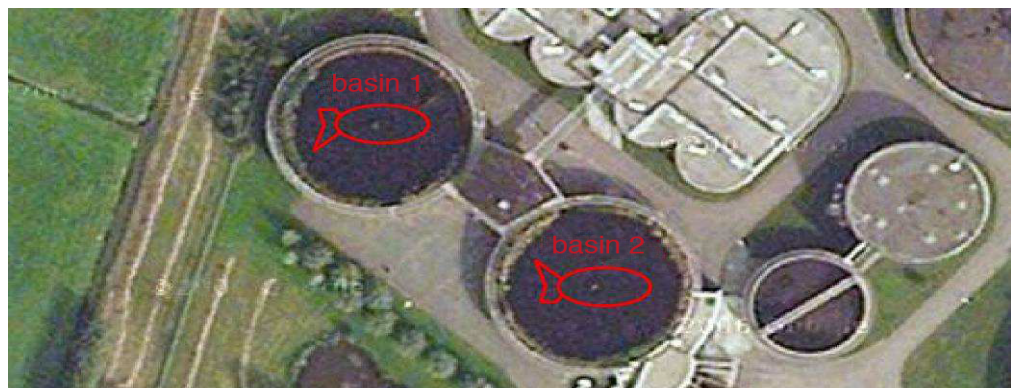
image 2.3 Distribution of the marked fish across the two basins. (Source: Google Maps)

To be able to determine in which basin a captured fish was released, the fish are marked through fin-clipping. The fish in basin 1 are marked at the top of the tail fin, in basin 2 the marking is at the bottom of the tail fin (see image 2.3).

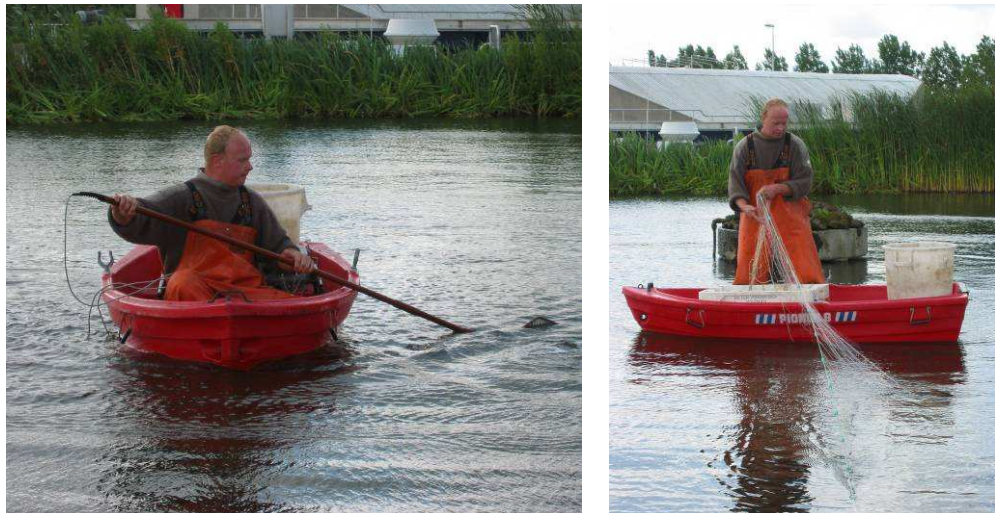
After placing the gillnet, fishing was done with an electro aggregate. Fishing with this device works best in shallow banks with water-growing plants. The banks of the basins, however, turned out to be quite deep and very steep, and the present vegetation grows above the waterline. These were therefore not ideal conditions for catching fish directly with the electro aggregate. However, by working with this device, the present fish population will be triggered to move, due to the shock reaction. As a result, the fish will swim into the gillnet faster and will thus get caught.

To be able to compare the fish population in both basins at different times, the same effort was applied for each fish population sampling and for each basin. For each sampling, the following procedure was repeated 3 times: 2 pieces of gillnet of different mesh sizes were placed in a circle within the basin and were removed after electrofishing.

image 2.4 The left picture shows electrofishing, the right picture shows the gillnet.
