Algae Control Aquaculture

The treatment of (fish) ponds on an environmentally friendly manner with the usage of LG Sonic ultrasonic algae control technology. LG Sonic's ultrasound technology reduces algae up to 90% and prevents the growth of new algae. The environmentally friendly ultrasonic sound waves provide a long term solution for a healthy ecosystem.

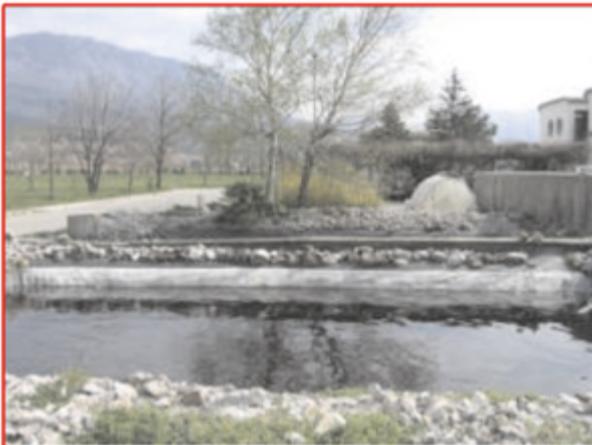
Experimental ponds.

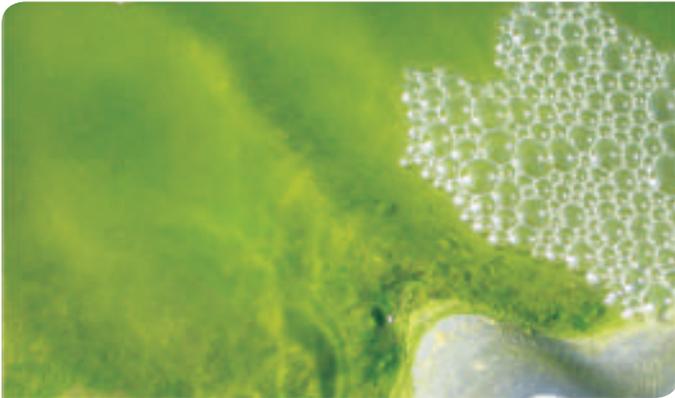
Reference pond

Algae are suspended in the water.

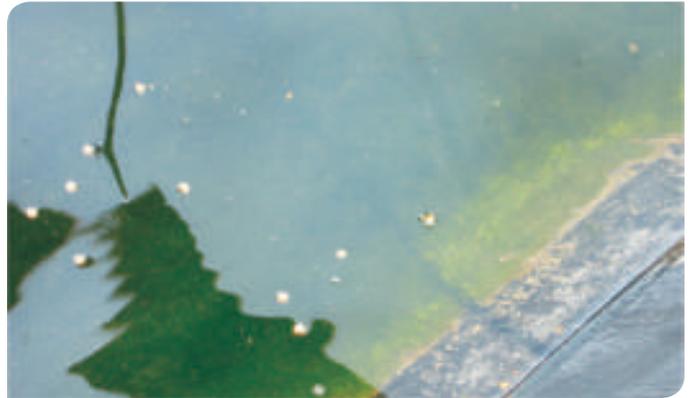
Algae are at the bottom of the pond

A difference could be seen within 1 week of LG Sonic treatment. Algae in the LG Sonic treated pond were at the bottom of the fish pond. At the other hand, the water that has not been treated is very green. Some Phd.'s in fishery biologist tested the behaviour of the fish (strain: *Cyprinus c. carpio* Linnaeus 1758) in both ponds.

The algae in the pond with the LG Sonic device were at the bottom of the pond. They were weakened and the water became clear. The algae in the LG Sonic® treated pond die slowly (many were still alive but weakened at the bottom of the pond). Chlorophyll molecules are good protected within their cellular body and thus are still able to do photosynthesis. Because of the relatively shallow (about 0,80 m) and very clear water they will still get enough sunlight. In this way they provide themselves with enough nutrients they synthesize, this might help in their own nourishing, thus causing them to die slowly. But, because the algae formed a sediment on the bottom of the pond, they are much easier to be removed. The fish in the LG Sonic treated pond can detect their food much easier because of the clear water. Certain stress, the fish normally encounter, in green water fishponds is not available in the pond with LG Sonic treatment. The fish in the LG Sonic treated pond are also a little bit heavier and the oxygen levels in the LG Sonic treated pond is slightly higher than in the reference pond.

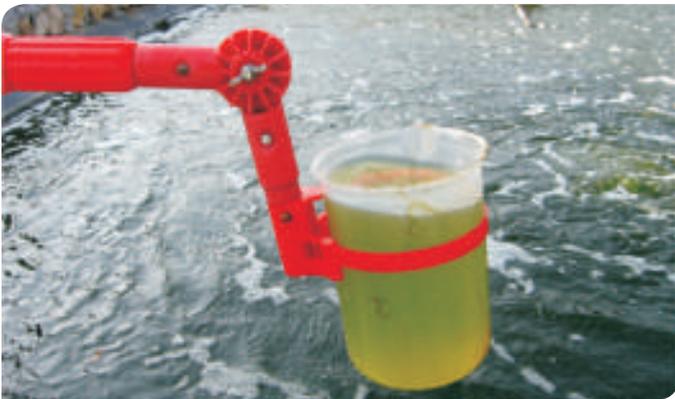
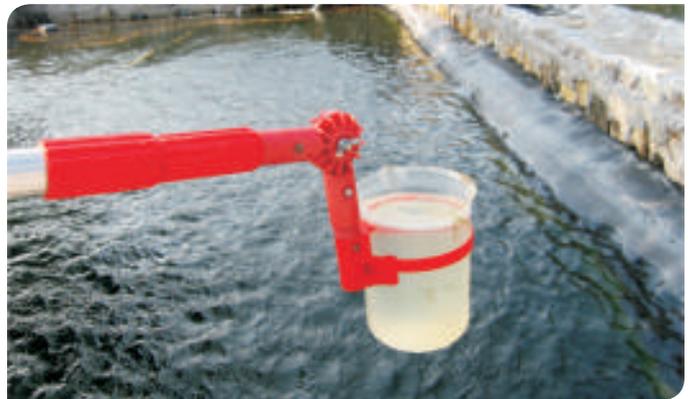
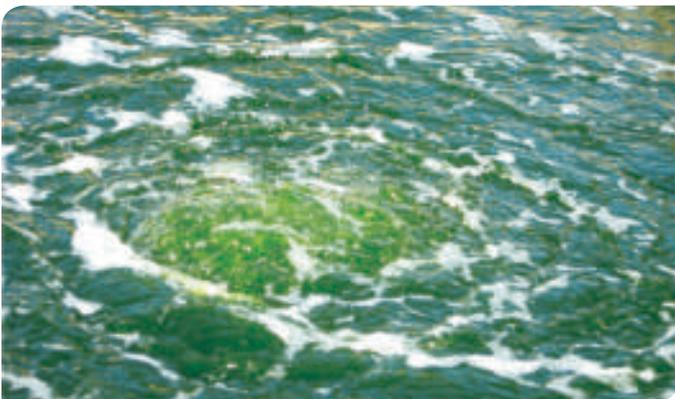
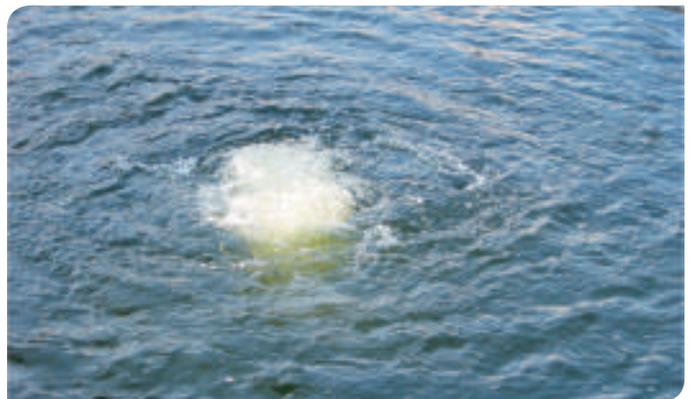
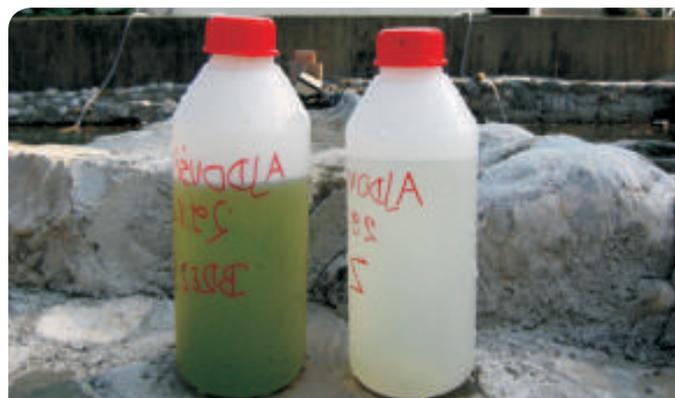
Reference pond water (left) and LG Sonic treated pond water (right)

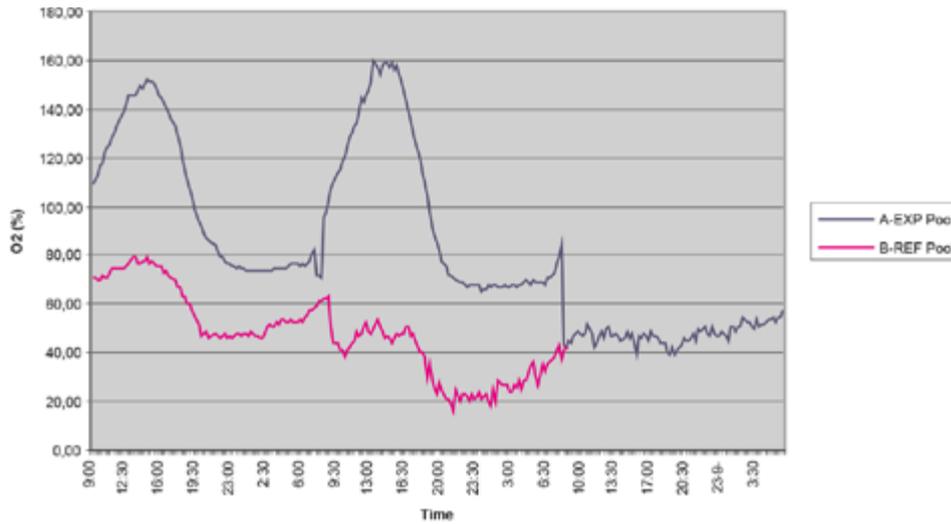
O2 % Monitoring

The results: no significant changes in the fish behaviour were detected. The oxygen level in the pond with LG Sonic treatment was slightly higher than the one without LG Sonic treatment.

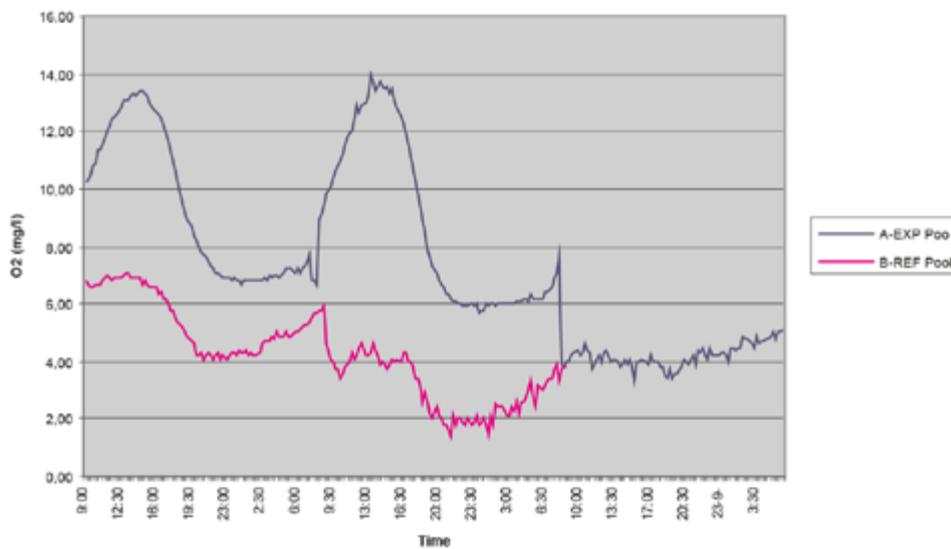
O2 mg/l Monitoring

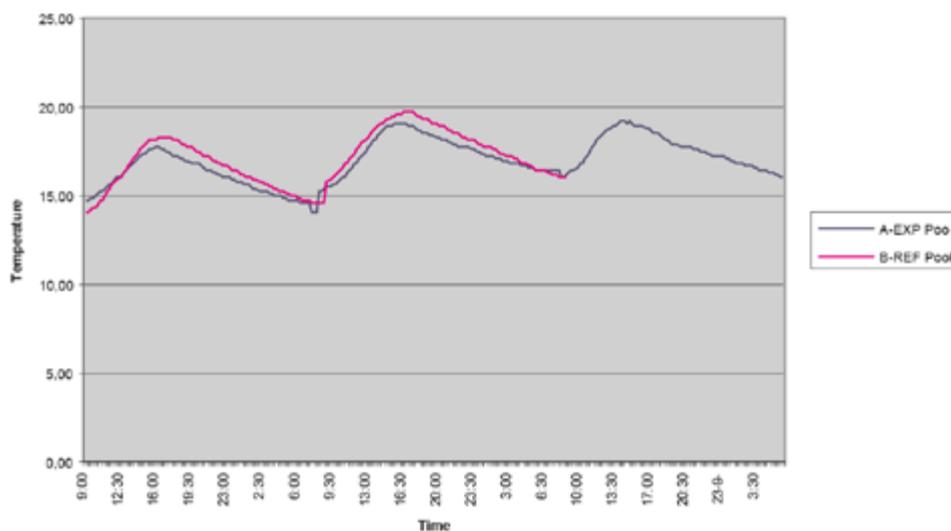
Temperature was stable during the test

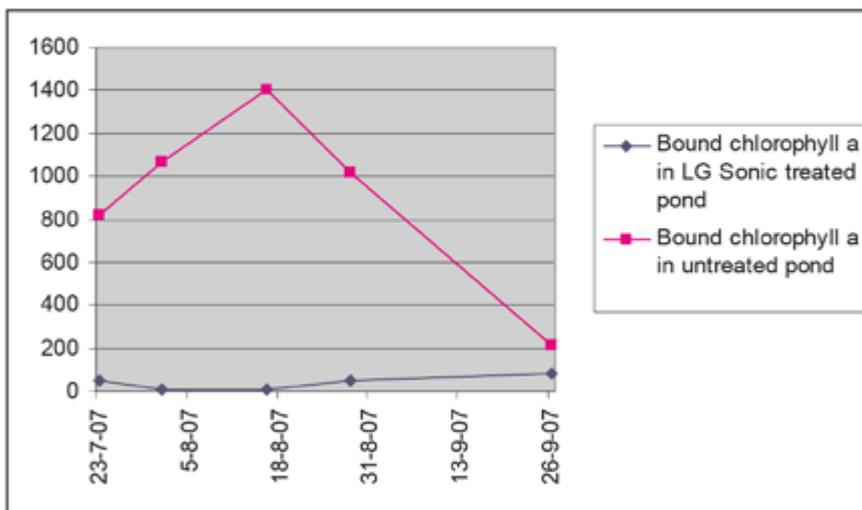
Levels of bound chlorophyll a in both ponds

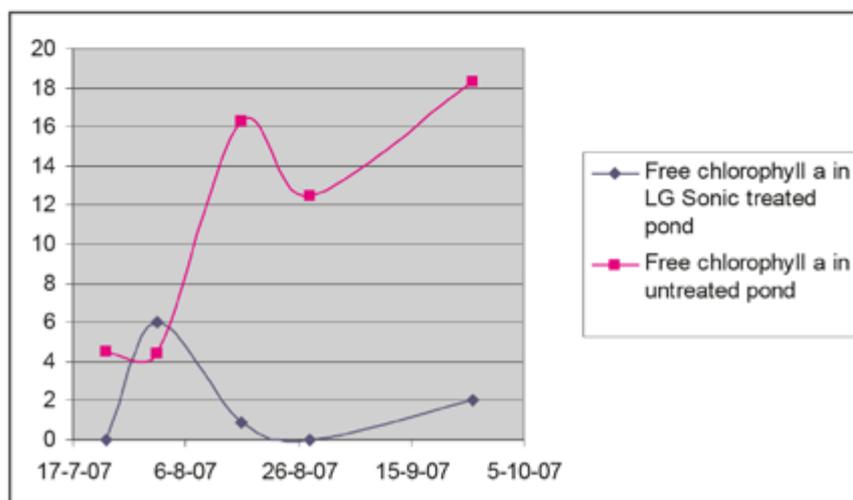
Levels of free chlorophyll a in both ponds

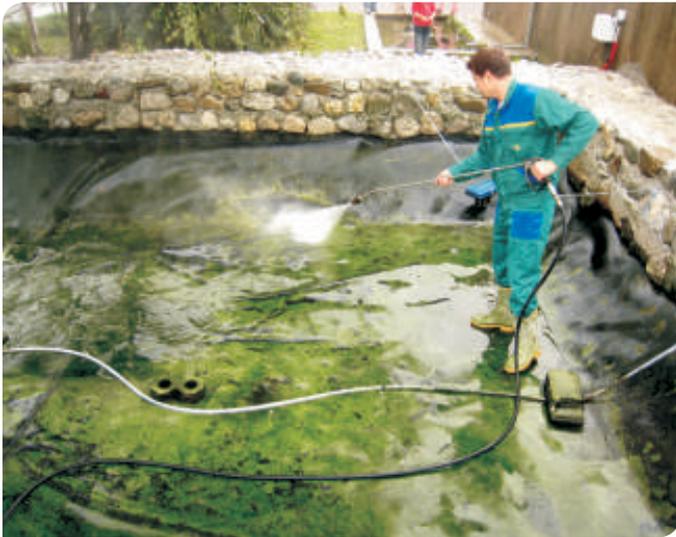
LG Sonic treated pond

Algae have formed a sediment on the bottom of the pond. Biofilm and algal layers were easy to remove.

Regarding fouling and biofilm formation on surfaces of the two ponds: When cleaning the ponds, the surface of the pond in which LG Sonic® has been used, is much cleaner than the reference pond. The pond in which LG Sonic is much easier to clean than the reference pond. Biofilm formation in the LG Sonic® pond seems to be much lower than in the reference pond. The original colour of the material (black) that has been used to cover the bottom of the pond can be seen clearly in the LG Sonic. At the other hand, the colour of the lining in the reference pond is now greyish. The original colour (thus, black) in the reference pond could not be recovered with the cleaning method which has been used.

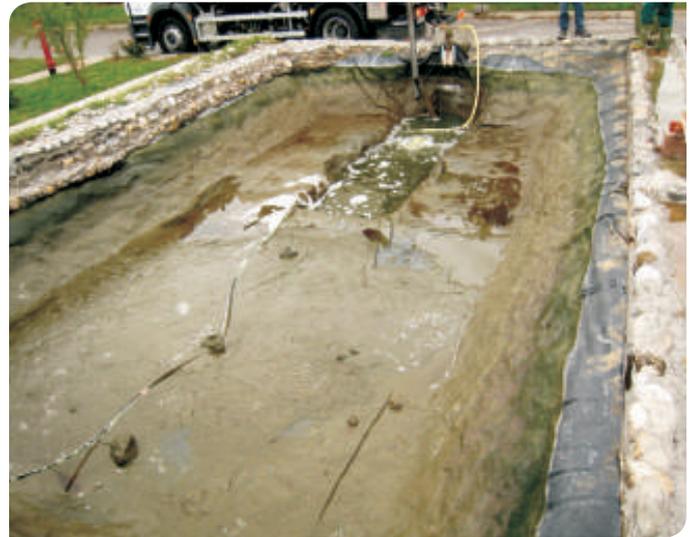
Untreated pond

Pond lining was covered with biofilm which was hard to remove even after scrubbing the lining.

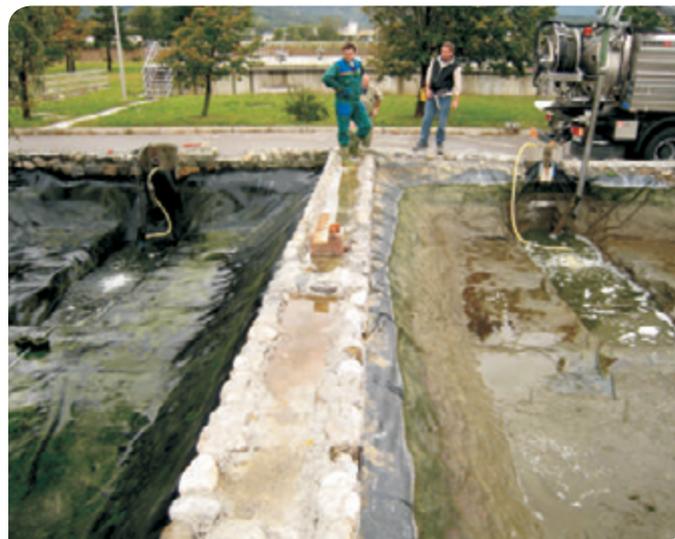
The untreated pond (right) contains a thick layer of biofilm even after cleaning. The LG Sonic® treated pond could be cleaned easily.
